Fatality Assessment and Control Evaluation Program

FACE Report Number: 2005-10

Traffic Control Supervisor Dies When Struck By An Asphalt Dump Truck While Picking Up Cones on a Roadway Work Zone - Tennessee

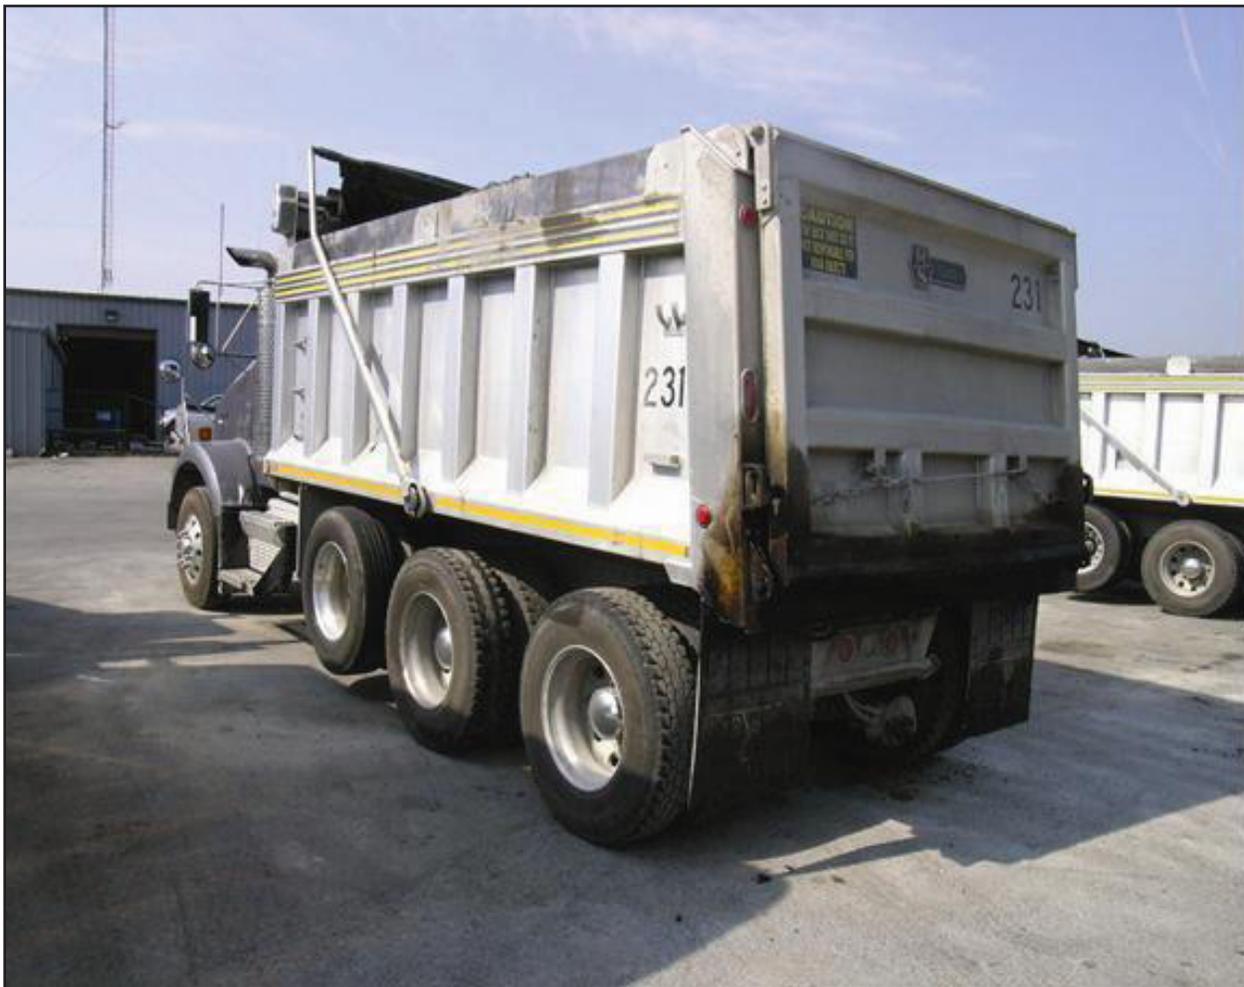
Equipment. The asphalt dump truck involved in this incident was owned and operated by the paving subcontractor. The diesel 5-ton tandem-axle truck was purchased new in 2004, and had a gross vehicle weight rating (GVWR) of 72,000 pounds (Photo 1).

Photo 1. Photo of the dump truck. [Photograph courtesy of the TOSHA].
