**SUBJECT:** A 54-year-old Hispanic worker was killed when he was crushed by a forklift.

## SUMMARY

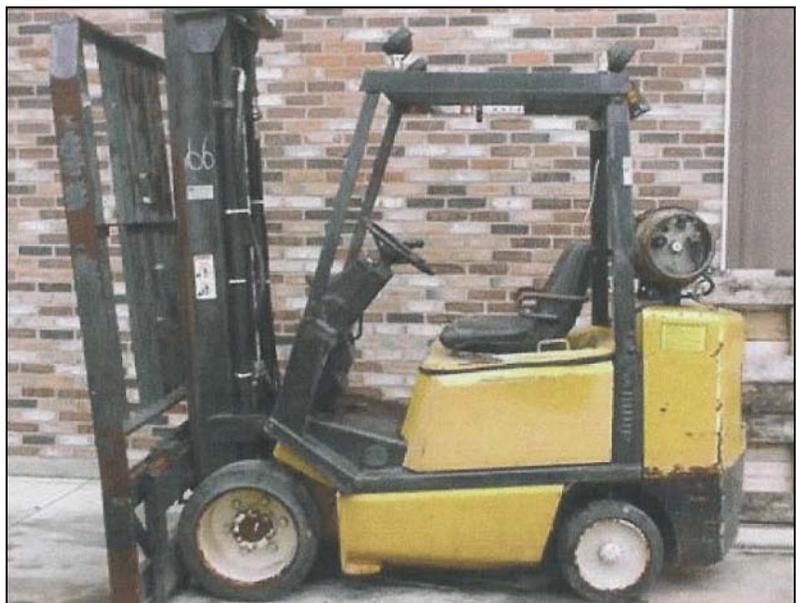
Figure 1. Forklift

A 54-year-old Hispanic forklift operator died on January 6, 2004, from crushing head injuries received when he was pinned by a forklift that overturned. He was operating the forklift on uneven terrain at the metal recycling facility where he was employed. The decedent was using a rented forklift to move a metal basket filled with scrap metal weighing approximately 1,500 pounds. He was not wearing a seat belt. As the basket was being unloaded into the pile of scrap metal, the forklift turned over and the victim was crushed beneath the cage of the forklift.

On the day of the fatal incident, the weather was cool and clear, and the working surfaces were dry. At approximately 11:30 a.m., according to the investigating officer, the decedent was conducting routine work in a metal scrap yard, moving scrap metal across uneven terrain to an area where it could either be cut into smaller pieces with a torch, or ground up into smaller pieces by a shredding machine. He was using a 5,000-pound capacity propane forklift with solid pneumatic tires that had been rented eight days prior to the incident. The company's regular forklift, which was undergoing repairs, was not the same configuration as the rented forklift; however, the rented forklift was the same model that the company had used in the past during repairs and it did come with an operator's manual. The employer-owned forklift was a 6,000-pound capacity diesel model and had been modified with an attachment to rotate the forks to allow operation in a more limited area. The victim was using the rented forklift to move a metal basket filled with scrap metal weighing approximately 1,500 pounds. The basket was 9 feet by 4 feet with a depth of 3 feet. The victim was wearing a hard hat, but not a seat belt. As the basket was being unloaded into the pile of scrap metal, the forklift tipped over and the victim was crushed beneath the cage of the forklift. There were no witnesses to the incident; however, a co-worker was on the scene almost immediately. Company officials immediately called 911; however, it took approximately 20 minutes to get the victim extricated from underneath the forklift. He was pronounced dead at the scene.

Discussion: The National Institute for Occupational Safety and Health (NIOSH) found that during a 14-year time period in which just over 1,000 workers died in forklift-related incidents, 22% were due to forklift overturns. The operator's manual for the rented forklift and NIOSH recommend the use of seat belts on sit-down type forklifts. Forklift manufacturers have been required to provide seat belts on new sit-down type forklifts since 1992. Many manufacturers can retrofit seat belts on older models. Employers should ensure the use of seat belts by periodic inspections and reminders. Properly secured seat belts keep the operator within the operator's compartment in the event of an overturn. Workers should also be reminded not to jump from an overturning, sit-down type forklift. Instead, they should hold onto the forklift firmly and lean in the opposite direction of the overturn. This fatality may have been prevented if the operator had been restrained and remained inside the operator's compartment.

Discussion: Operators should be trained on any special operating characteristics, including the specific vehicle, operating surfaces, and environment. OSHA standards address the following issues: surface conditions, composition of loads, load manipulation, pedestrian traffic, restricted operating areas, hazardous locations, ramp and sloped surfaces, closed environments, and any other unique or potentially hazardous environment in the workplace that could affect safe operation. In this case, the forklift was being operated on uneven terrain. The owner's manual of the rented forklift cautioned the operator to avoid bumps,

holes, and loose materials. The use of an all-terrain forklift may have helped prevent this incident.
