**SUBJECT:** A yard hand was killed when he was crushed between the mast and the rollover protective structure of a forklift.

## SUMMARY

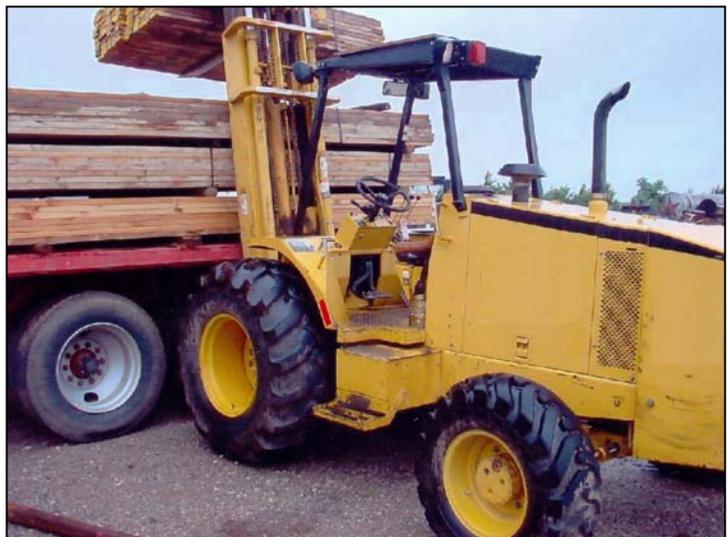
Figure 1. Forklift involved in the incident

**Incident Scene:** The employer used the incident site to store, load, and unload construction materials. The yard surface was composed of a gravel/chat/soil type mix. A company 40-foot flatbed trailer had been loaded with lumber, and the victim was assigned to redistribute the load. There were three employees, including the decedent, at the site when the incident occurred—a truck driver and two part-time yard hands. The victim was using a 6,000-pound lift capacity, rough terrain forklift that had been owned by the company for five years (Figure 1). The incident occurred early in the workday around 7:45 a.m.

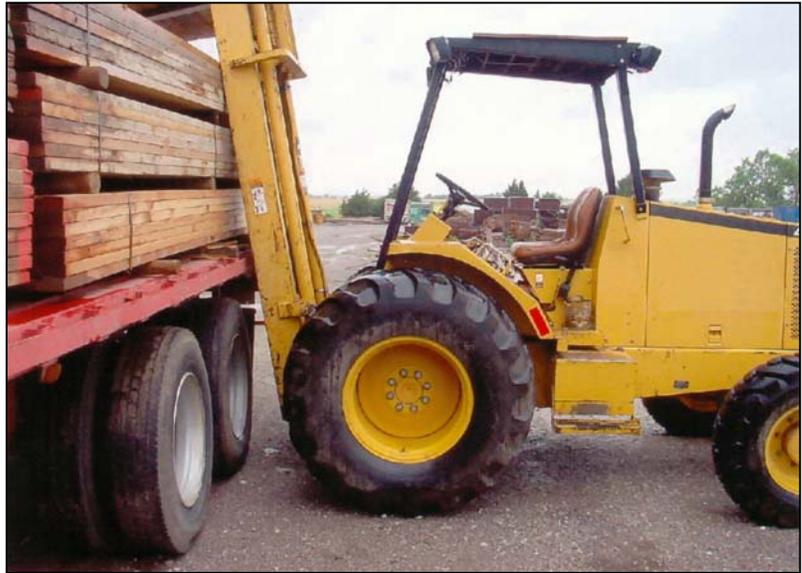
In an attempt to move one bundle of wood forward to even the weight, the victim raised the bundle in the air, well above the height of the trailer and its load. The forklift was only a few inches from the edge of the trailer at this time (Figure 2). Leaving the engine running, the decedent stepped out onto the front left fender of the forklift and reached across to remove four spacers. His body was positioned between the forklift mast and the top edge of the ROPS.

Figure 2. Forklift's position prior to incident.

Unable to reach the blocks from the forklift fender, he stepped across to the edge of the trailer with one foot and was able to remove three of the four. He then attempted to move across the front edge of the operator's compartment to the right fender. As he did, his foot engaged the tilt control lever and the mast began to move back, as the forklift was still running. The decedent had no time to react and was crushed. The decedent was wearing regular work boots, but the wet conditions may have contributed to his foot hitting the lever. In the operator's compartment was a caution label with the operating requirements to be performed prior to leaving the operator's seat: "Before leaving operator's seat; lower working units to the ground, place transmission gear selector lever in neutral, place reverser lever in neutral, engage parking brake, and stop engine." It was determined that both yard hands routinely used the forklift fenders to reach loads on the trailers.

**Recommendation #2: Employers should ensure that forklift operators do not position themselves between the uprights of the mast, outside the running lines of the truck, or work under elevated forks or loads.**

Discussion: The OSHA standards for powered industrial trucks also indicate that authorized operators shall not place arms or legs outside the running lines of the truck or between the uprights of the mast. Furthermore, no one should pass or work under elevated portions of the truck under any circumstances, unless the forks have been chained and locked out to an overhead hoist, crane, or beam capable of supporting the weight. When the truck is running, the operator must remain inside the operator's compartment; power should be shut off when leaving a powered industrial truck unattended. Proper instruction and supervision of employees will give workers the knowledge of these and other safe operating procedures to prevent misuse of equipment.
